Fractographic Analysis of the Low Energy
Fracture of an Aluminum Alloy
by

J. Tanaka, C. A. Pampillo and J. R. Low, Jr.

Metallurgy & Materials Science
Carnegie-Mellon University
Pittsburgh, Pennsylvania 15213

NASA Technical Report No. 1

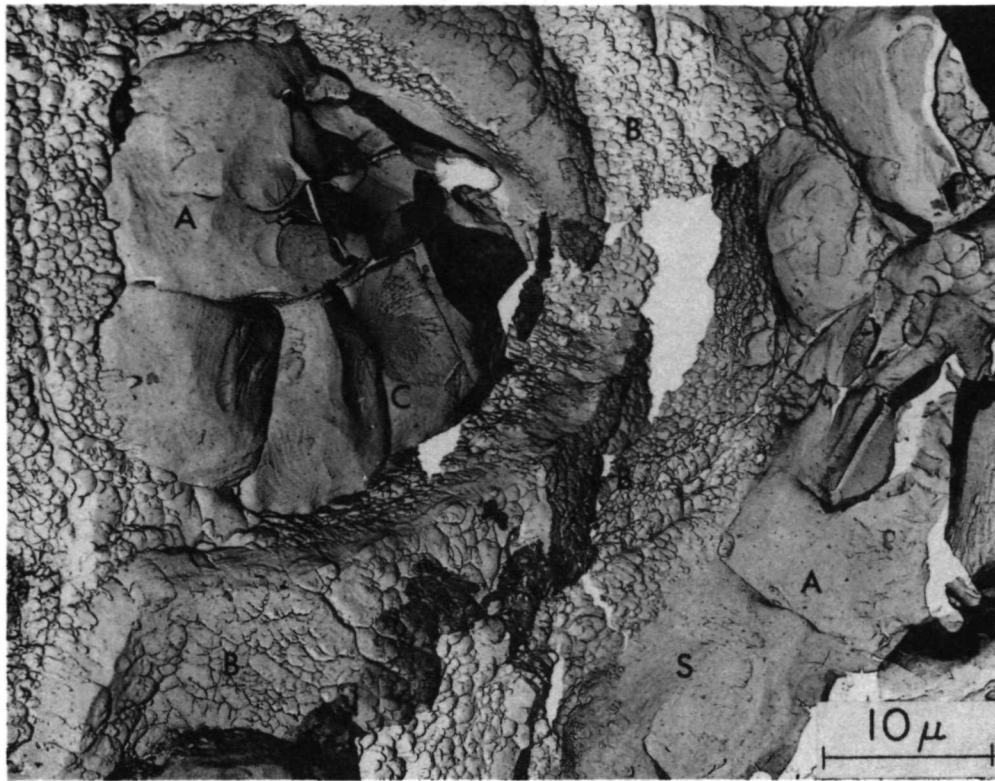
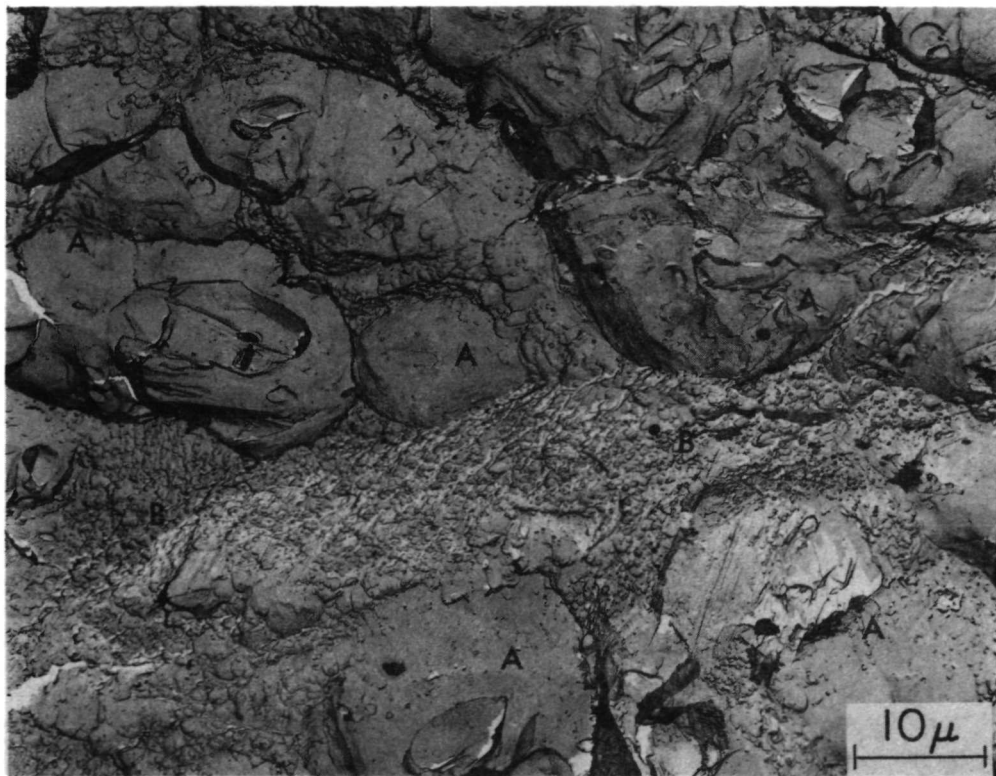
Figures 2 and 3 show typical electron microscope fractographs. A dimpled topography was found over the entire fracture area observed. The most salient feature to be noted here, is that two widely different sizes of dimples are present; moreover, they are not randomly distributed but form groups, or colonies, of large (10 to 30 microns) dimples (A) separated from similar areas by bands of small (0.5 to 2 microns) dimples (B). In some areas of some of the large dimples, features typical of a cleavage pattern, (C) are observed. These are thought to be due to the fracture of an inclusion which failed by cleavage and nucleated the void. The greater proportion (50-60%) of the fracture surface is covered by large dimples and it is very likely, then, that the most important factor leading to the low toughness of the alloy is the existence of the particles which nucleate the large size dimples.

Figures 2 and 3 Two Stage Plastic-carbon Replica of Fracture Surface. Large Dimples at A - Small Dimples at B - Cleavage Pattern at C

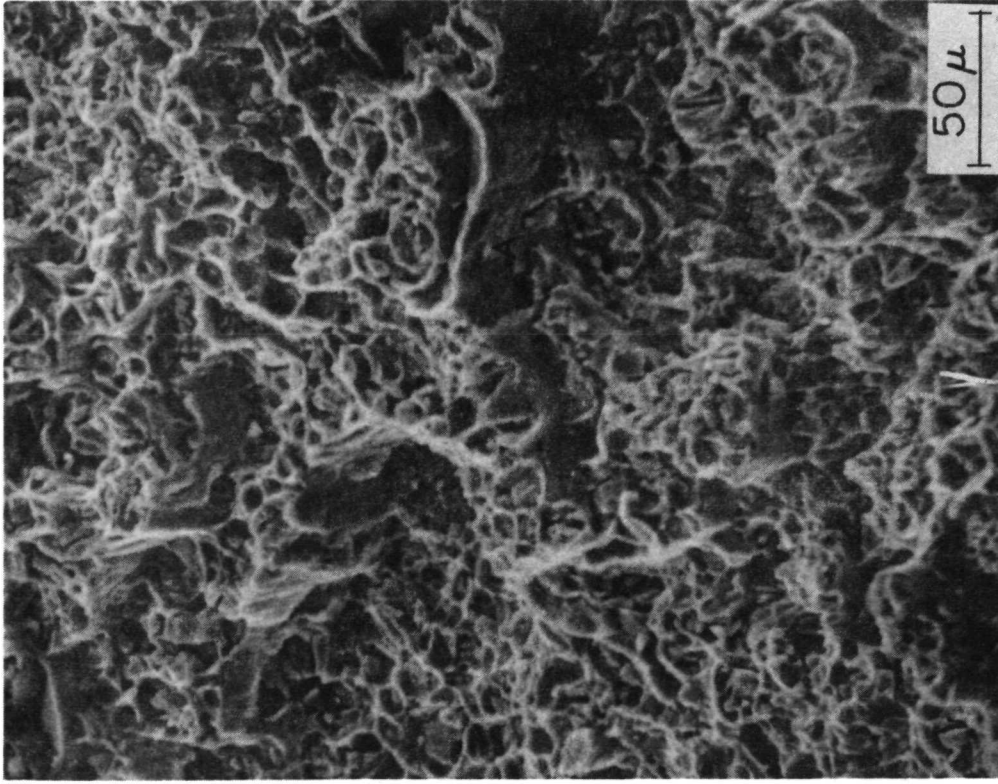
Figure 4 shows a low magnification fractograph taken with the SEM of the fracture surface of one of the toughness specimens. By careful examination it is possible to distinguish areas with the same large dimples seen in the replicas and smoother areas which at higher magnifications, Figures 5 and 6, show the topography of the small dimples. "A" marks the same point in the three micrographs of Figures 4, 5 and 6. All these micrographs were taken with secondary electrons. Figures 7 and 8 compare, at low magnification, the same area taken with secondary electrons and with back scattered electrons. When back scattered electrons are used, deep shadows appear where secondary electrons showed areas of small dimples (smooth at low magnifications). This means that these areas of small dimples are steps on the fracture surfaces joining areas covered by large dimples that lie at different levels (back scattered electrons give an effect similar to highly oblique light in the optical microscope). The reason why these areas did not appear as steps on the fractographs obtained by replicas is that these steps are too large and the replicas probably collapse, showing large size and small size dimples at the same level. (See Figures 2 and 3)

Fig. 4 Scanning Electron Microscope Micrograph Showing Large Dimples and Smoother Areas at A (secondary electrons).

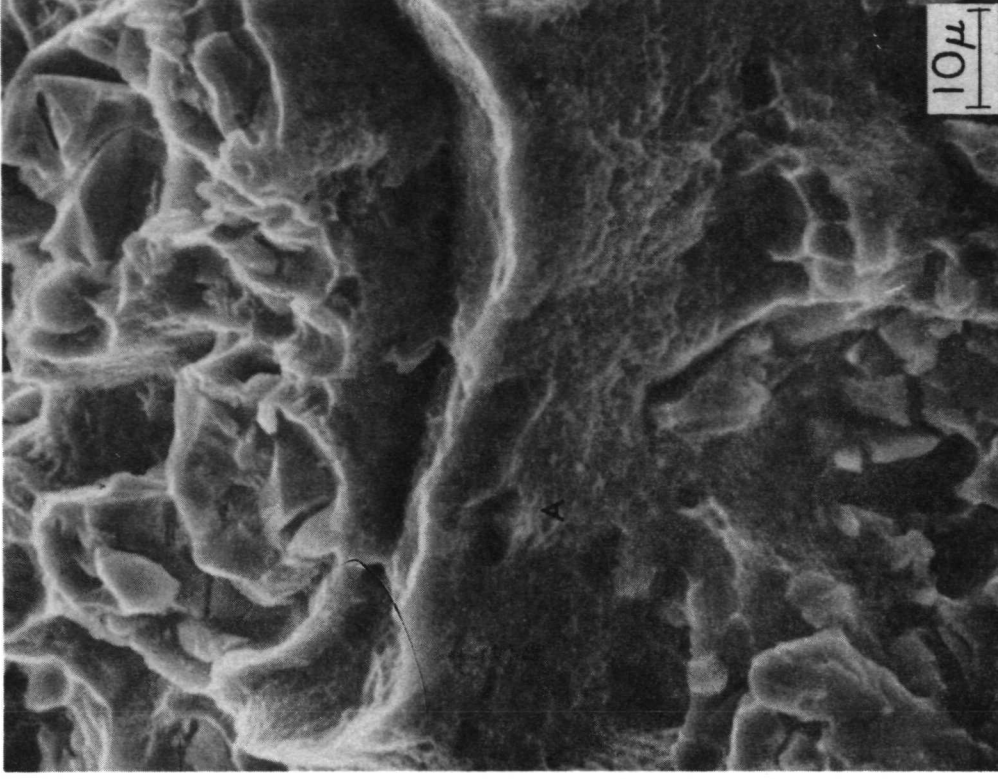
Fig. 5 Same as Fig. 4 at Larger Magnification (secondary electrons) A is the Same Spot as in Fig. 4

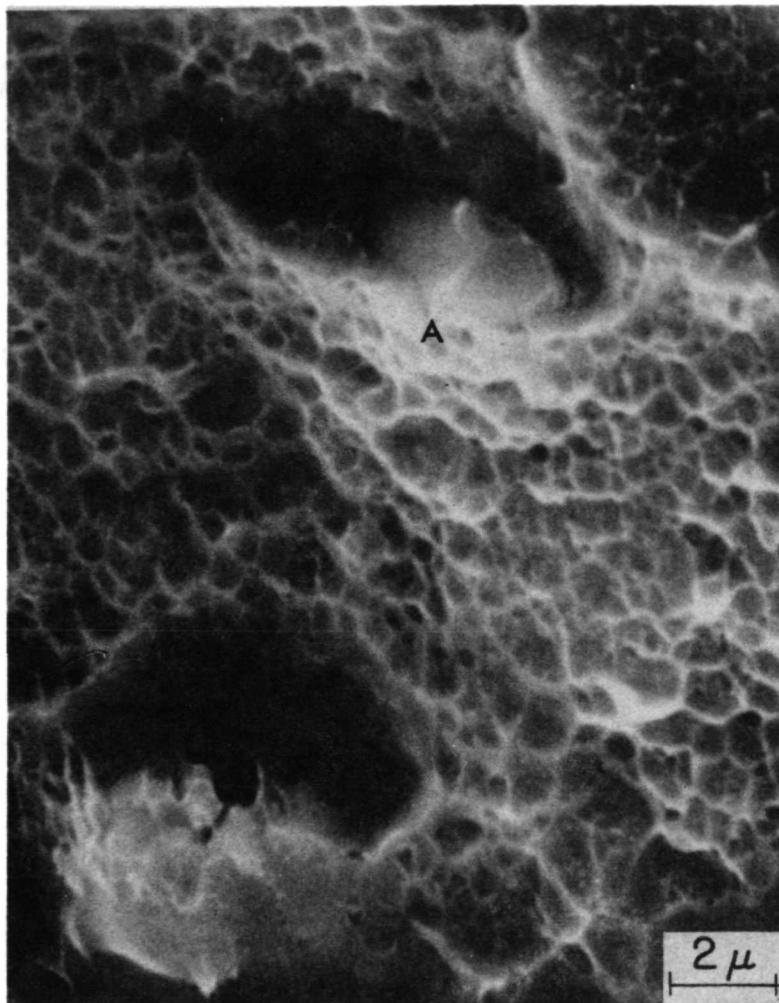
Fig. 6 Same as Fig. 4 and 5 at Higher Magnification Showing Small Dimples on Smoother Areas of Fig. 4 (secondary electrons) A is the Same Spot as in Figs. 4 and 5

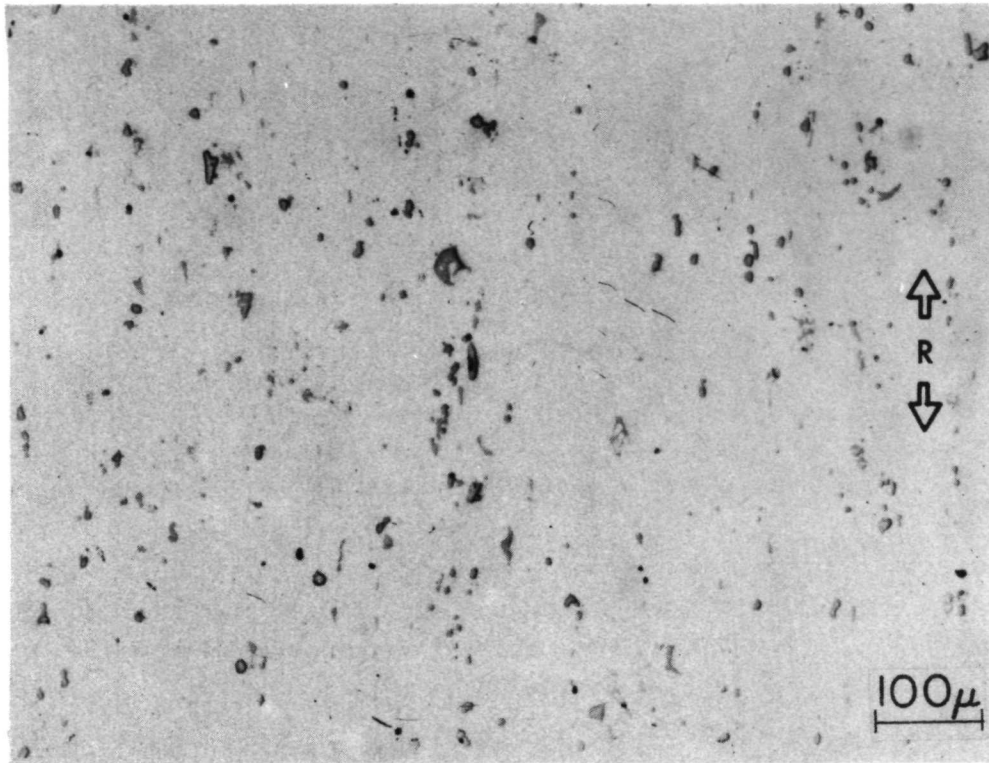
Figure 9 shows an optical micrograph of a mechanically polished section of the material. Large inclusions, 3 to 10 microns in diameter, separated by a distance of 5 to 15 microns from each other, may be seen. In some cases, grouping of these inclusions into colonies were observed, but the general distribution was quite uniform except for a certain tendency of the inclusions to be aligned along the rolling direction (marked as R in Fig. 9).

Fig. 9 Optical Micrograph of a Mechanically Polished Surface of the Alloy

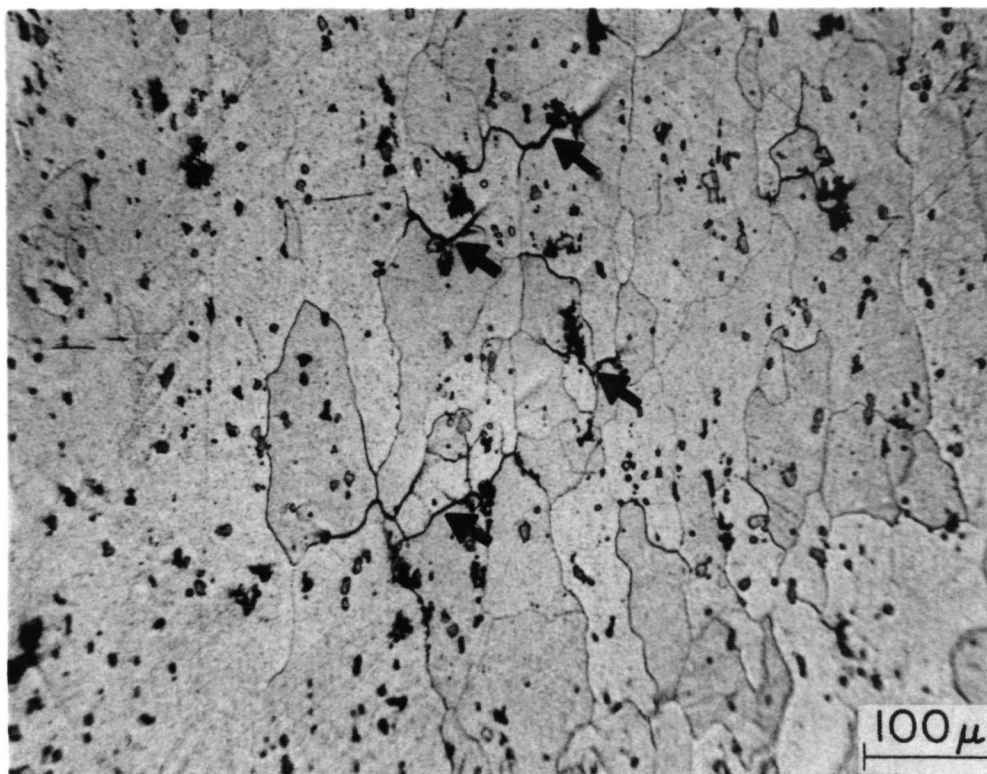
Fig. 10 Optical Micrograph. The Polished Surface was Etched to Delineate Grain Boundaries After Cracks (arrows) had Appeared as a Result of Bending Deformation

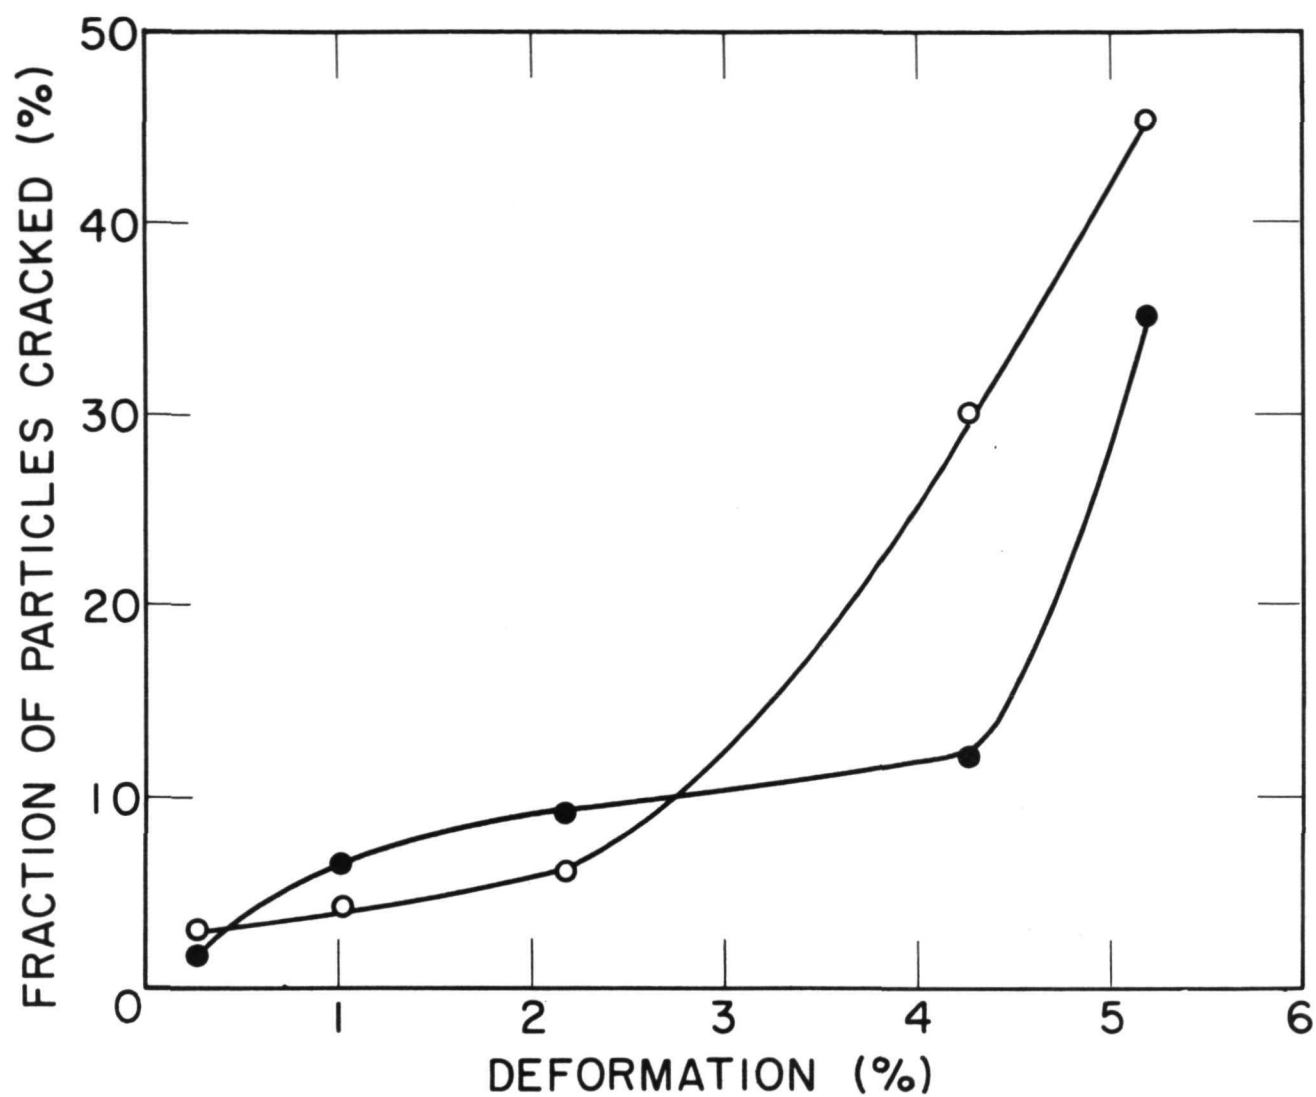
mid section and the other to the free surface of the specimen. The ratio of cracked particles to the total number of particles greater than 1 micron in diameter, is shown in Figure 11 as a function of deformation. The solid circles correspond to the observations made at the free surface and the open circles at the mid section. It is clear that the particles start cracking at the early stages of deformation. The fraction of cracked inclusions increases steadily up to a point where the maximum load is reached, after which the rate of cracking increases sharply.

Fig. 11 Fraction of the Inclusions Greater than 1 Micron Found Cracked as a Function of Tensile Plastic Deformation. Solid Circles Correspond to Observations Made at the Free Surface of the Specimen and Open Circles at the Mid Section

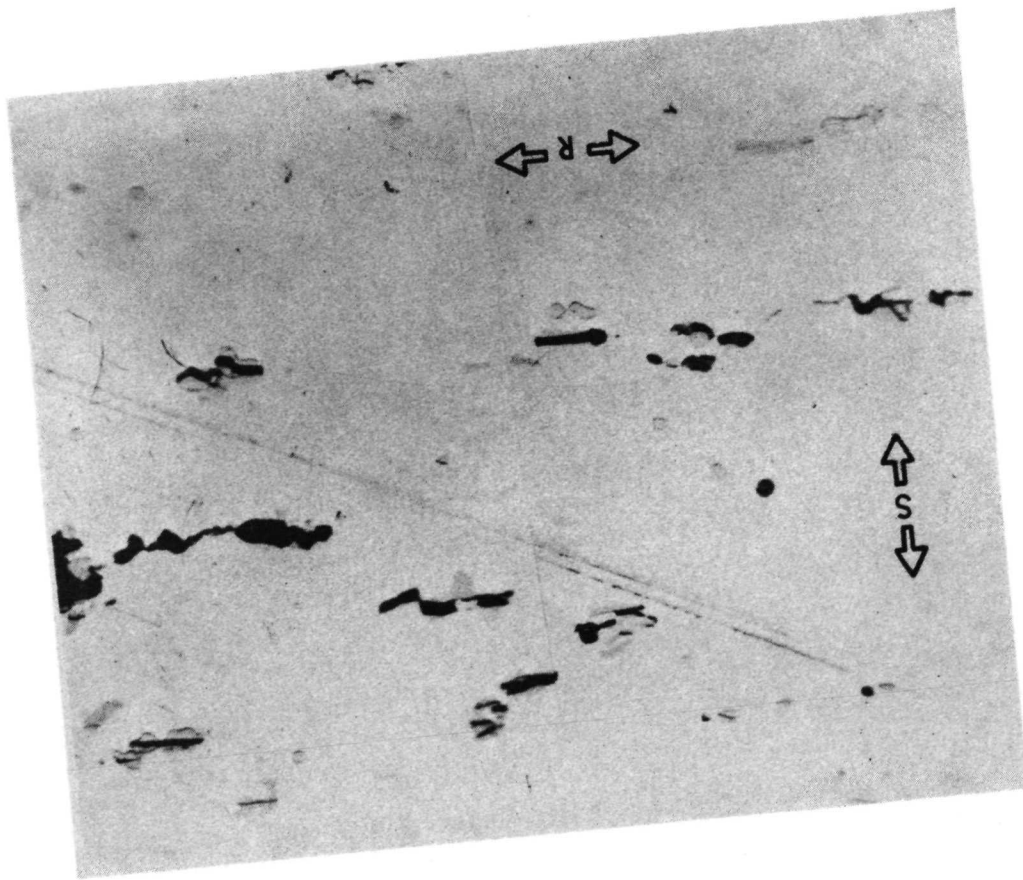
The cracks formed at the inclusions were only seen to propagate into the matrix for the largest deformations and this was observed more frequently at the mid section, Figure 12 (S shows the stress direction). Blunting of the cracks formed at the inclusions were observed in some cases and this was due to failure at the particle matrix interface, as shown in Figure 13 by arrows. Some evidence of grain boundary cracking is found in specimens with the larger deformations. This is shown in Figure 14 by arrows. The different appearance of the crack as compared with that in Figure 10 is believed to be due to rounding of the edges by polishing.

Fig. 12 Polished Surface of Fractured Tensile Specimen Showing Growth of Cracks. S is the Tensile Axis and R the Rolling Direction

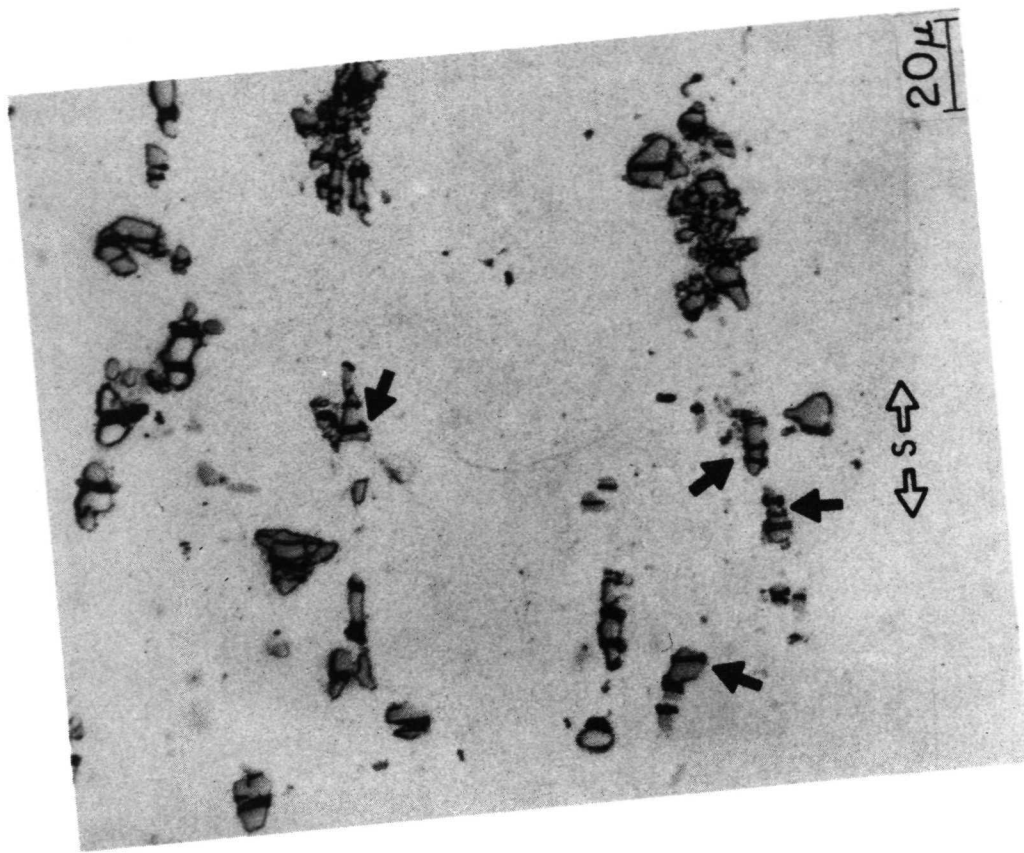
Fig. 13 Polished Surface of Tensile Specimen Showing Blunting of the Cracks in the Inclusions (arrows). S is the Tensile Axis

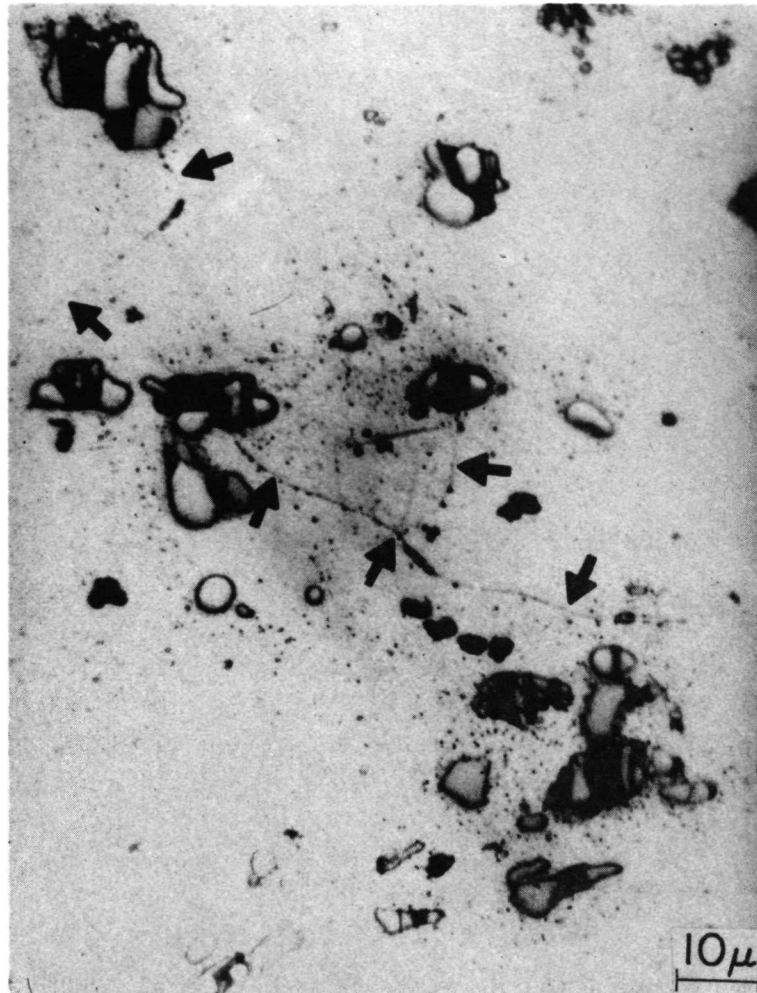
Fig. 14 Polished Surface of Tensile Specimen Showing Grain Boundary Cracking (arrows)

The fractographs seem to show a situation by which several voids nucleated at large particles coalesce somewhat at the same level and parallel to the main fracture surface. Thereafter they join with other similar areas by a mechanism of void sheet formation⁽⁹⁾ leading to the rupture of the ligament between these areas. The void sheet formation mechanism seems to be developed through the formation of voids at small particles distributed uniformly in the matrix, or in some cases, at the small inclusions found at the grain boundaries. It is difficult to distinguish the areas covered by small dimples which are related to grain boundaries and those which are not. However, features such as the one seen in Figure 14, could well be related to grain boundary failure.

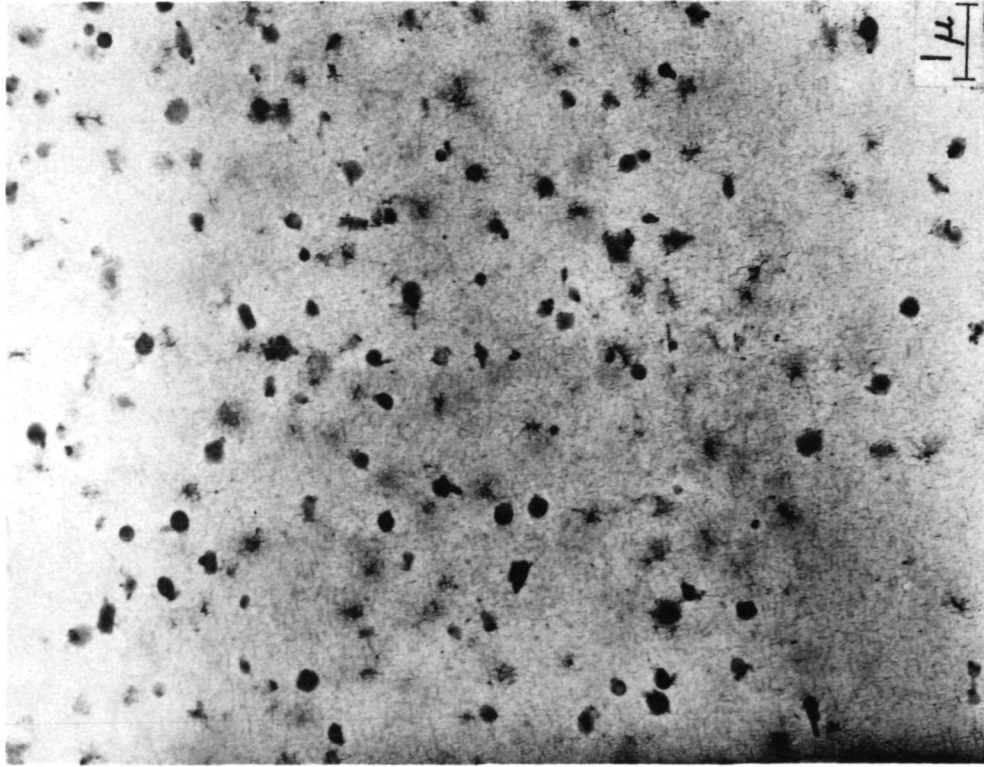
The small size dimples seen on the fracture surfaces were very likely nucleated at particles too small to be observed with the optical microscope. Moreover the observation that some in grain boundary cracking occurred without showing typical intergranular fracture appearance in the fractographs, suggested that a precipitation free zone around grain boundaries might exist in the alloy. This is known to lead, in some cases, to grain boundary failure with a dimpled fracture topography⁽²⁾. With this in mind, thin films of the alloy were examined in the electron microscope. The thin films were prepared by a jet electropolishing technique⁽³⁾ using a mixture of 2/3 Methanol and 1/3 Nitric Acid. Figure 15 shows a typical transmission electron micrograph. Small particles about 0.1 to 0.2 microns in diameter a distance of about 0.5 to 1 micron apart are clearly seen. Because of their size and distribution, these should be regarded as a dispersion which strengthens the matrix. The work hardening characteristics of the alloy should be especially affected by them⁽⁴⁾. This coarse dispersoid, which contributes significantly to the strength of the alloy in addition to the fine θ precipitate, has been identified as $\text{Al}_{12}(\text{Mn}, \text{Fe})_3 \text{Si}$ ⁽⁸⁾.

Fig. 15 Transmission Electron Micrographs Showing
a Fine Dispersion of Particles

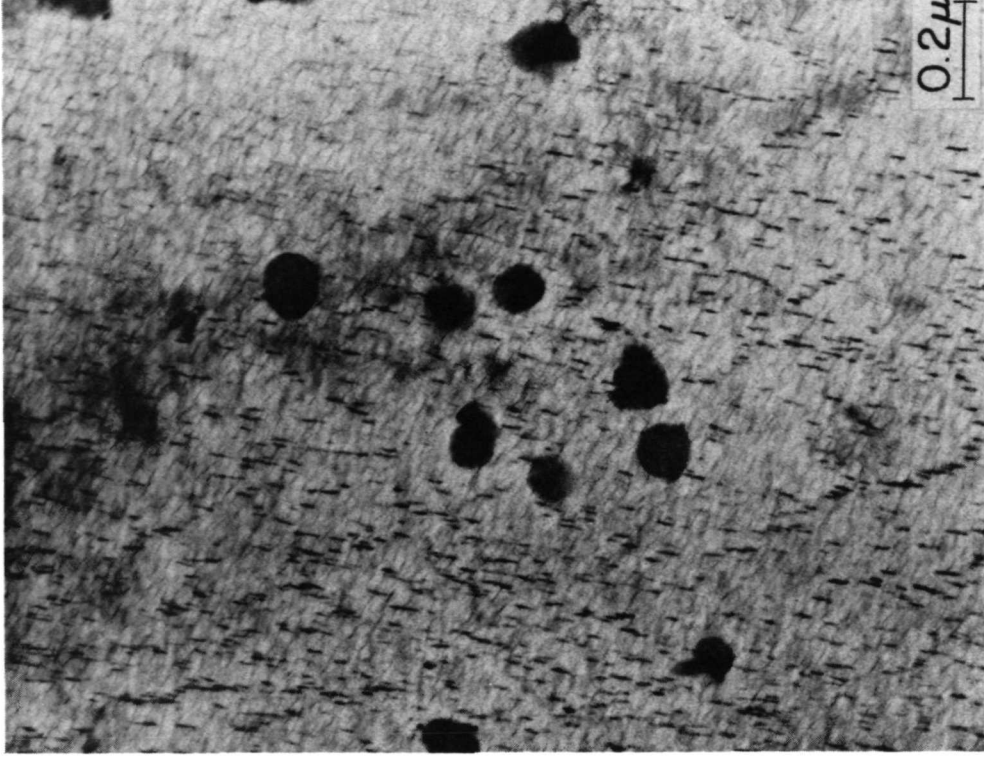
At higher magnifications, Figure 16, the matrix shows a structure formed by a fine elongated precipitates 0.01 to 0.05 microns long which are believed to be the principal hardening precipitates. No precipitation free zone was found around grain boundaries but elongated inclusions 0.3 to 0.5 microns long were observed, Figure 17. This finding may well explain the grain boundary cracking observed in the bending and tensile specimens. The fact that the fracture topography was of the dimple type and did not show any evidence of grain boundary interface failures may also be understood. In effect, the existence of grain boundary failure showing a dimpled topography

Fig. 16 Transmission Electron Micrograph Showing
Dispersed Particles and Hardening Precipitates

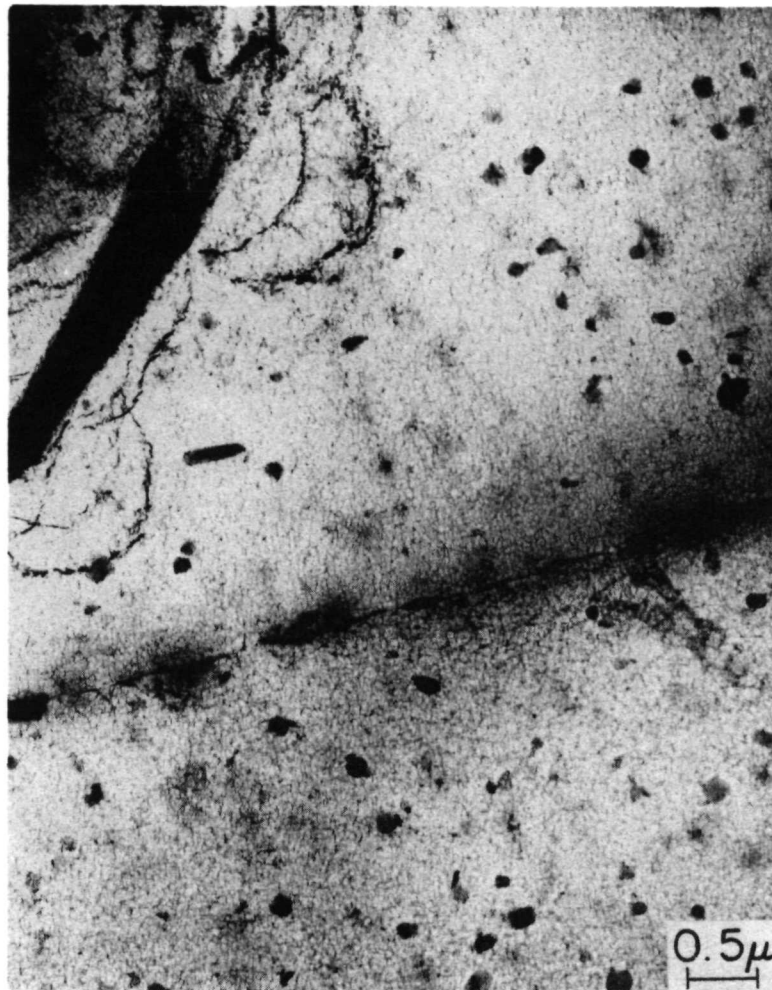
Fig. 17 Transmission Electron Micrograph Showing Small Inclusions at Grain Boundaries

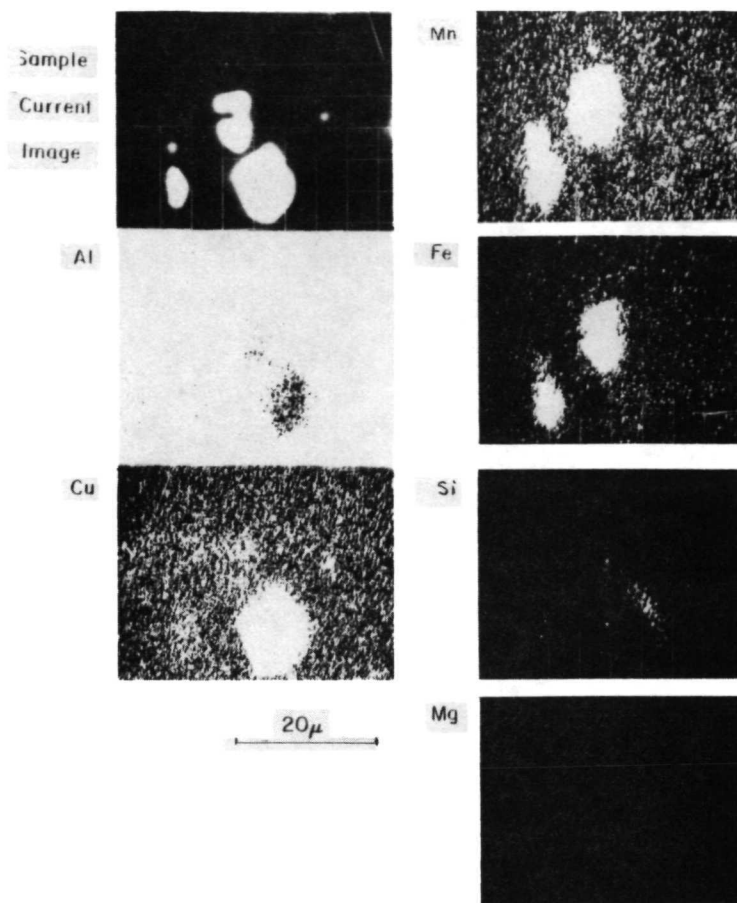
Polished samples, in which inclusions were easily seen in the optical microscope, were first analysed to determine the elements present in all of the large inclusions. Figure 18 shows typical micrographs obtained with the micro probe analyser. The top left picture shows the sample current by which it is possible to show the location of the particles. The remaining picture show the distribution of each of the specific elements investigated. Particles containing Fe, Mn and some Si are found in general, together with some particles containing large amounts of Cu. In these polished-section micrographs, it is not possible to decide if the particles contained Al because of interference from the Al matrix.

Fig. 18 Electron Micro Probe Analysis of a Polished Sample of the Alloy

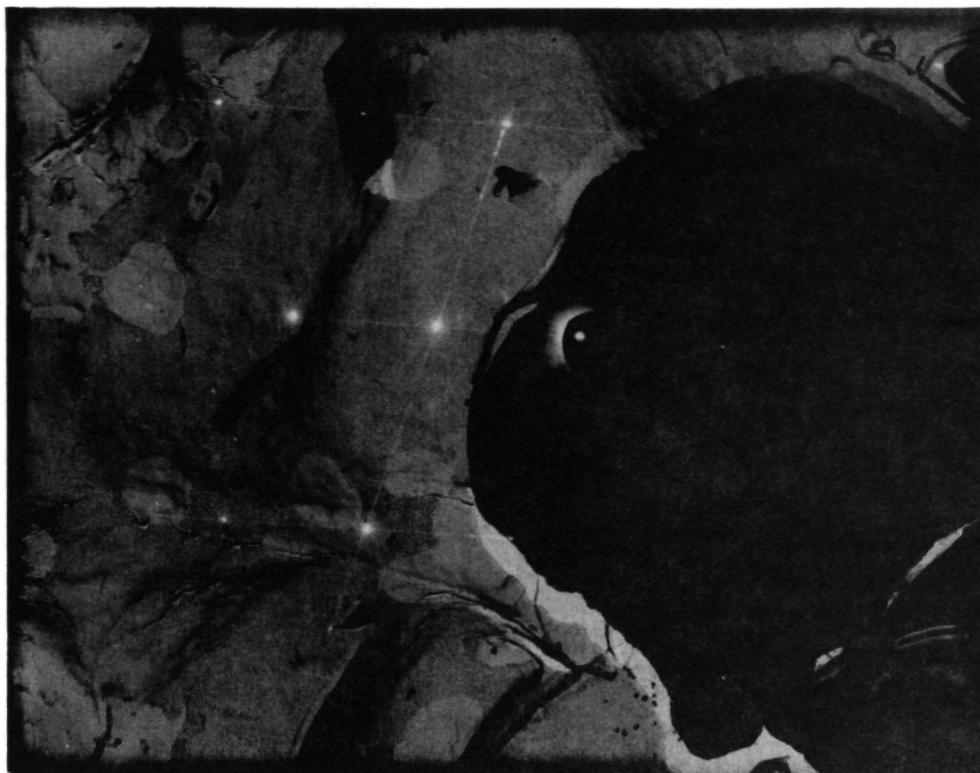
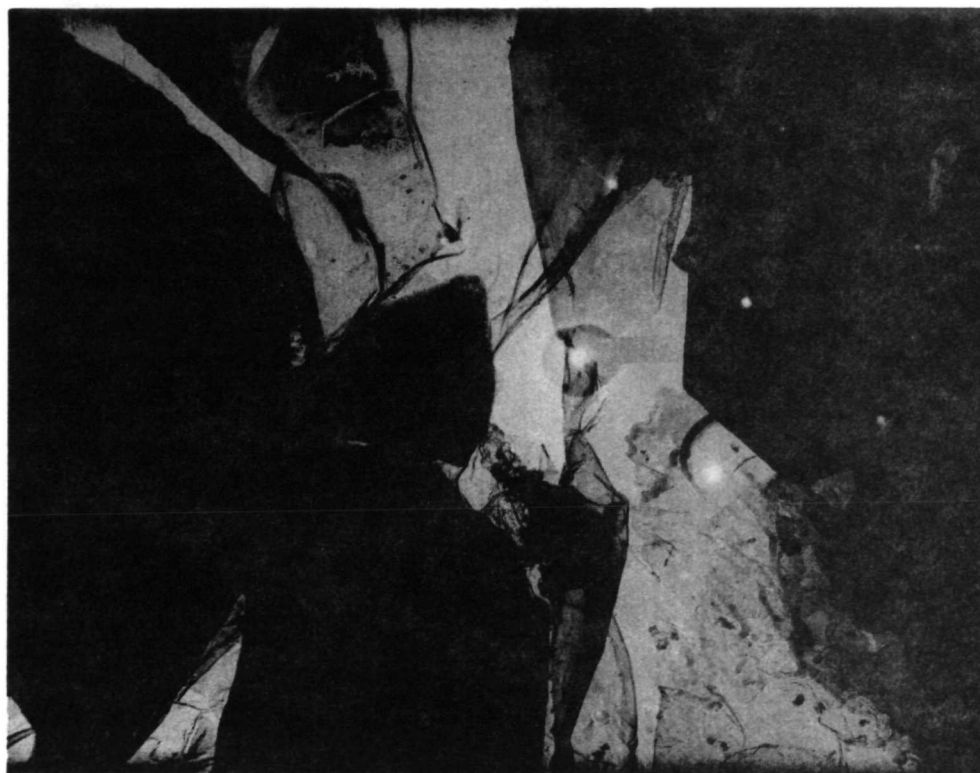
Fig. 22 a & b Electron Diffraction Patterns of Particles A and B of Fig. 20

Figures 22a and b shows diffraction patterns for the particles A and B shown in Figure 20 and in the micro probe micrograph in Figure 21. An analysis of the diffraction patterns obtained of the particles in the extraction replicas might correspond to Al_4Cu_9 or $\text{Cu}_{15}\text{Si}_4$ and pure Si or Cu_5Si or CuAl_2 .

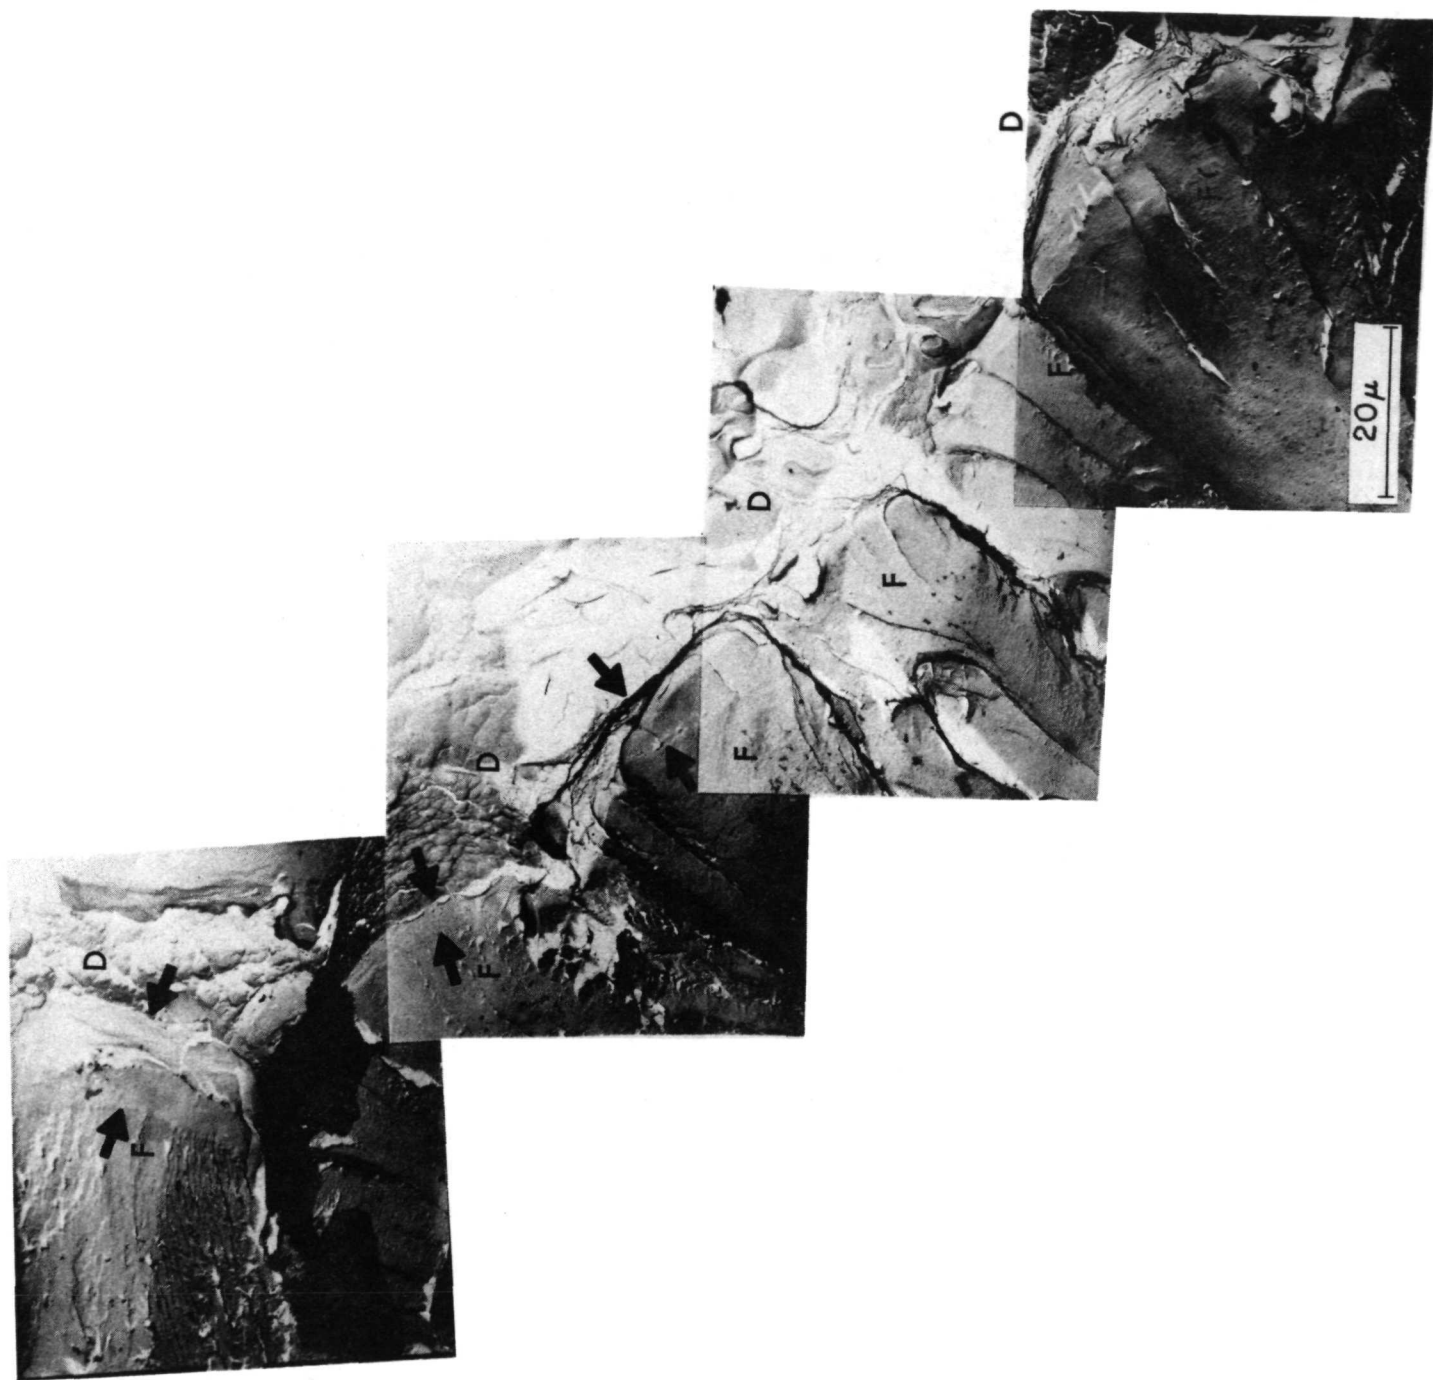
Figure 23 shows an electron fractograph taken from a two stage plastic-carbon replica made at the boundary between the fatigue (F) and the dimpled ruptures (D) regions of the fracture surface. The fatigue region in this material does not show the striations typical of fatigue. However, the features of the dimpled rupture region are quite different from these of the fatigue region which may be seen more clearly in a low magnification fractograph taken with the scanning electron microscope, Figure 24.

Fig. 23 Electron Microscope Micrograph of a Two Stage Replica of the Boundary Between Fatigue (F) and Overload Region (D).

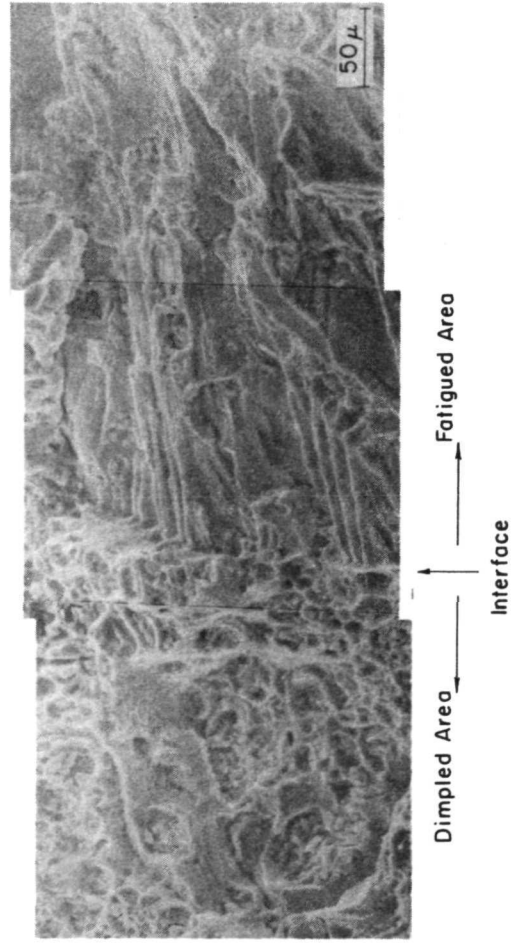
Fig. 24 Low Magnification Electron Micrograph Taken With the Scanning Electron Microscope of an Area Similar to that in Fig. 23

At the boundary between the two regions, a step may be seen, Figure 24, which does not appear clearly in replicas due perhaps to collapse of the carbon film which will not support such a step. In any event, a topography different from both the dimpled rupture and the fatigue region is seen at the boundary, (shown between arrows) Figure 23. This transition area has been called the stretched-zone⁽¹³⁾ and its topography of the surface is said to be made up of almost wholly of "serpentine glide" due to slip⁽¹⁰⁾. It is apparent from Figure 23 that the extent of this region is quite irregular. Two scanning electron micrographs at higher magnification of the stretched zone are seen in Figure 25. The step seen at lower magnification in Figure 24 now appears to be rounded. The sketch shown in Figure 26 shows, we believe, the situation at the tip of the crack just before critical instability. We therefore believe that the stretched zone is produced during blunting of the crack tip and perhaps some stable crack growth. Several correlations have been made recently between the size of the stretched zone and fracture mechanics data. The result seems to be that the size of the stretched zone is of the order of $G_{Ic}/4\sigma_y$, where G_{Ic} is the critical crack extension force and σ_y the yield stress⁽¹¹⁾. If we take $G_{Ic}/2\sigma_y$ as a measure of the "crack opening displacement" (COD) at instability (the factor 1/2 is used when considering plane strain conditions)⁽¹⁴⁾, then, roughly, the radius at the tip of the crack just before instability is of the order of one-half to one times the crack-opening-displacement in size.

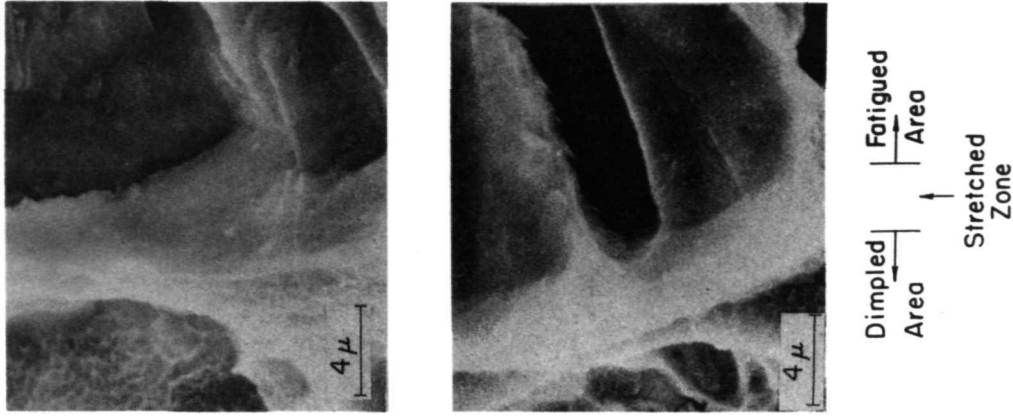
Fig. 25 High Magnification of Areas in Fig. 24 at the Boundary
